Project: 20_5837_11_29
Site: 5 Barrens Close, Woking, GU22 7JZ
Client: Afsha Ahmed

Document Title:	Arboricultural Implications Assessment
Document Author:	Ffion Maguire
Project Manager:	Matt Harmsworth
Project Title:	5 Barrens Close, Woking, GU22 7JZ

Arboricultural implications assessment to BS 5837 2012 of trees at: 5 Barrens Close, Woking, GU22 7JZ.

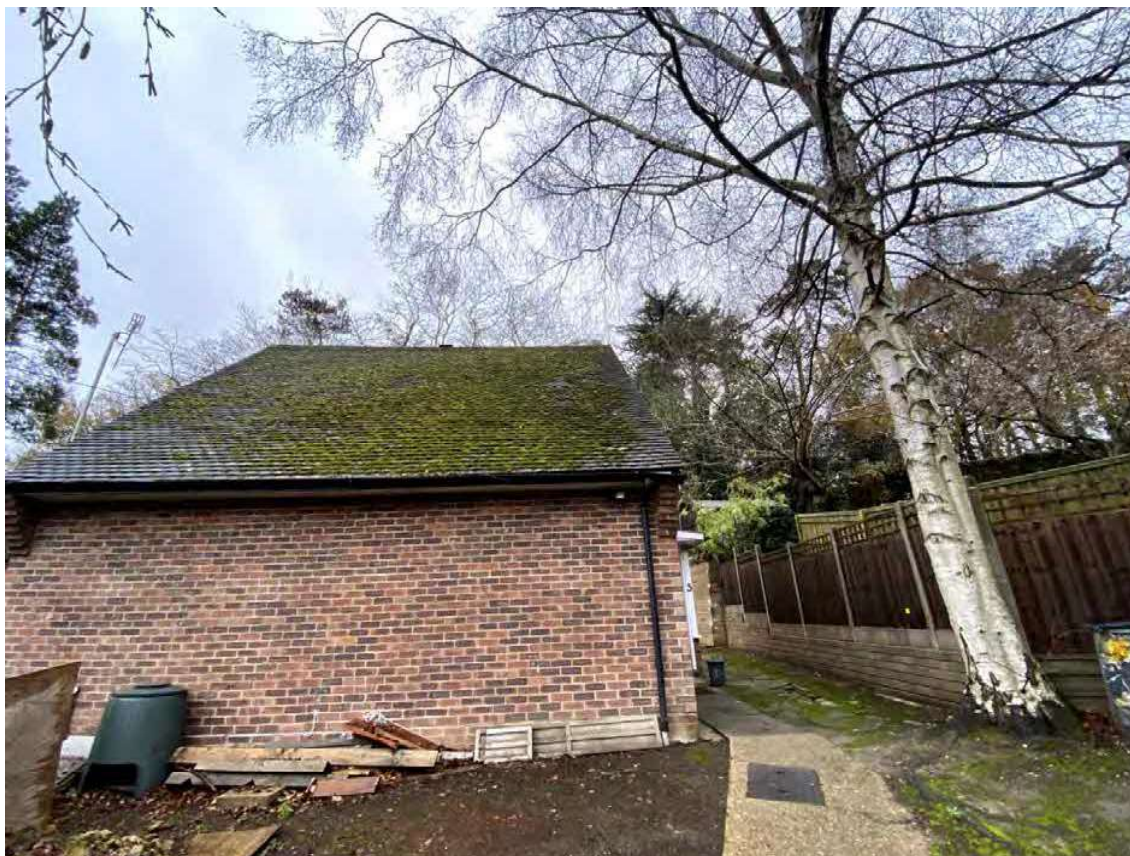
Photographic plate showing tree T1, a mature Silver Birch.

- 4.8 Tree T1 is a mature Silver Birch located on the site's northern boundary, approximately 2.5m from the residential dwelling house. The tree is growing within a hard surface area of concrete and paving. Subsequently, the roots are lifting the footpath. The tree has poor shape and form. Mechanical damage was observed. The branches are encroaching upon the adjacent building. It is recommended to dismantle and fell the tree.

It is recommended to dismantle and fell tree T1, regardless of any new developments as the tree has limited long-term prospects due to location and is causing structural damage to the existing build footprint.

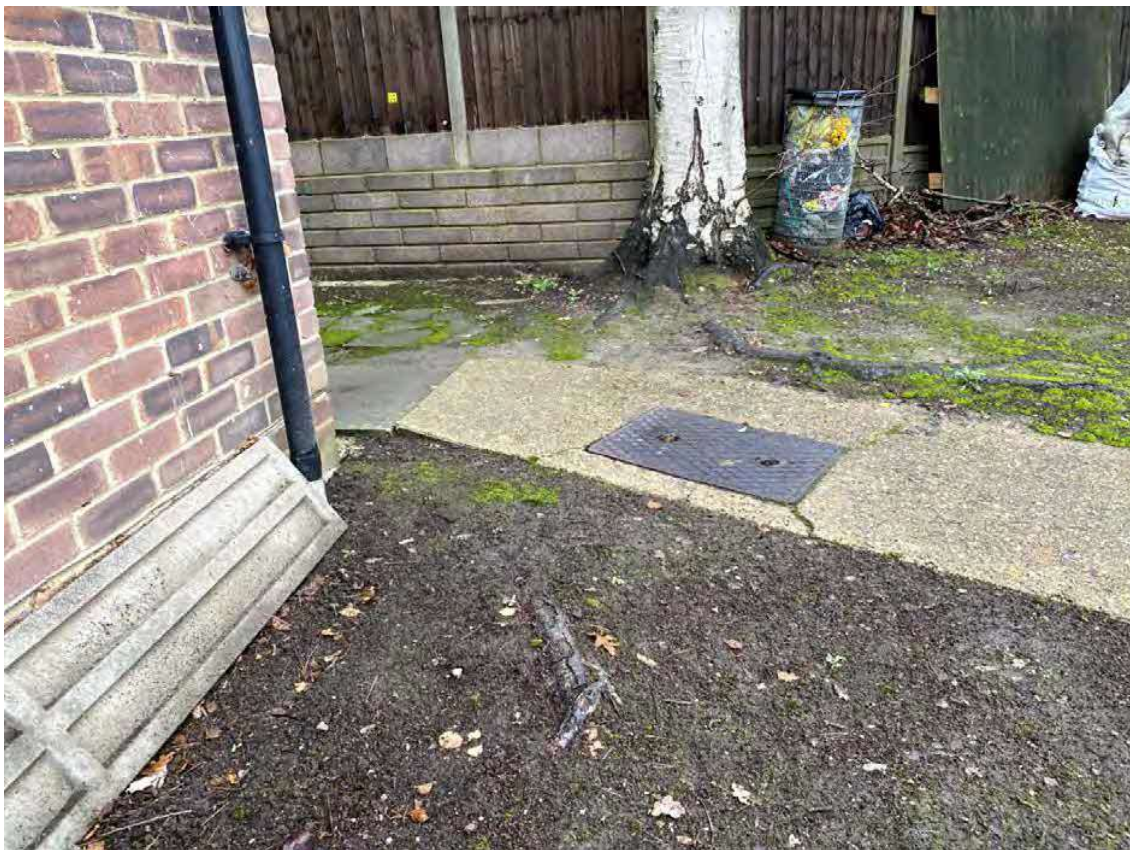
Photographic plate showing the roots of tree T1 encroaching upon the residential property.

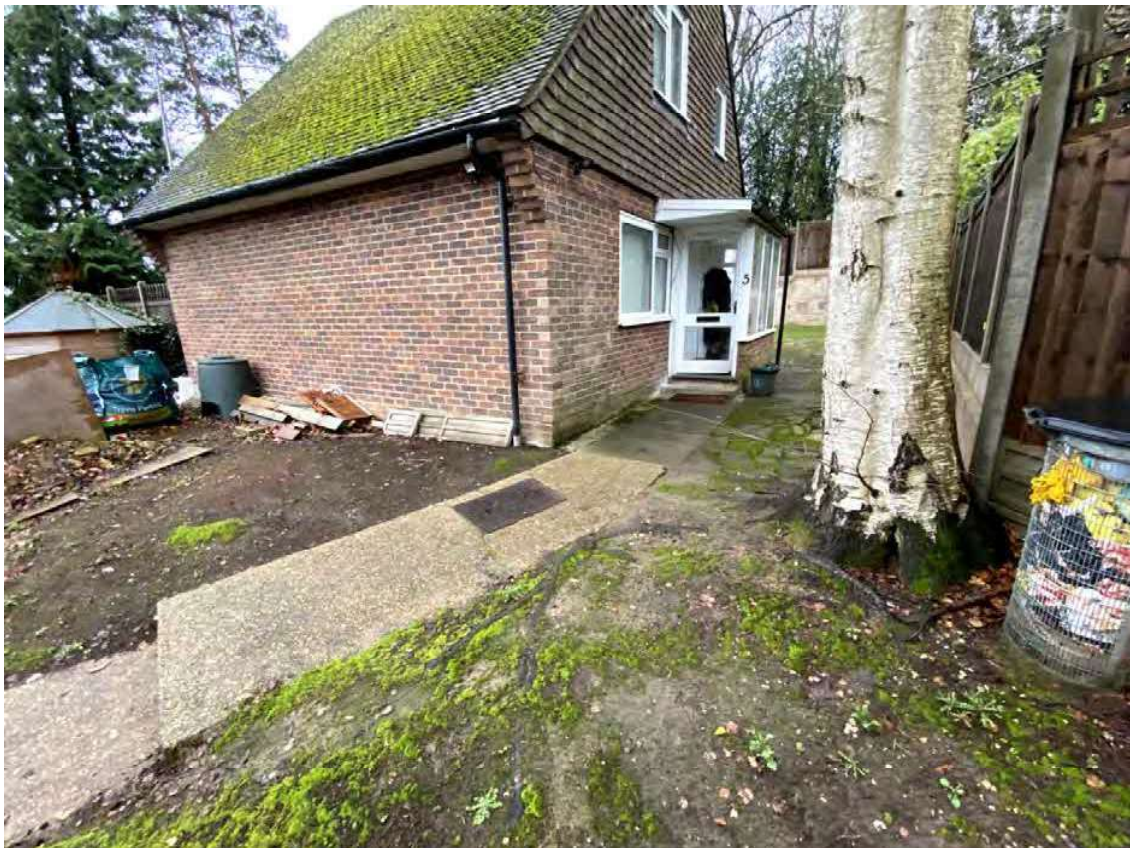
Photographic plate showing tree T1, located adjacent to the residential dwelling house.

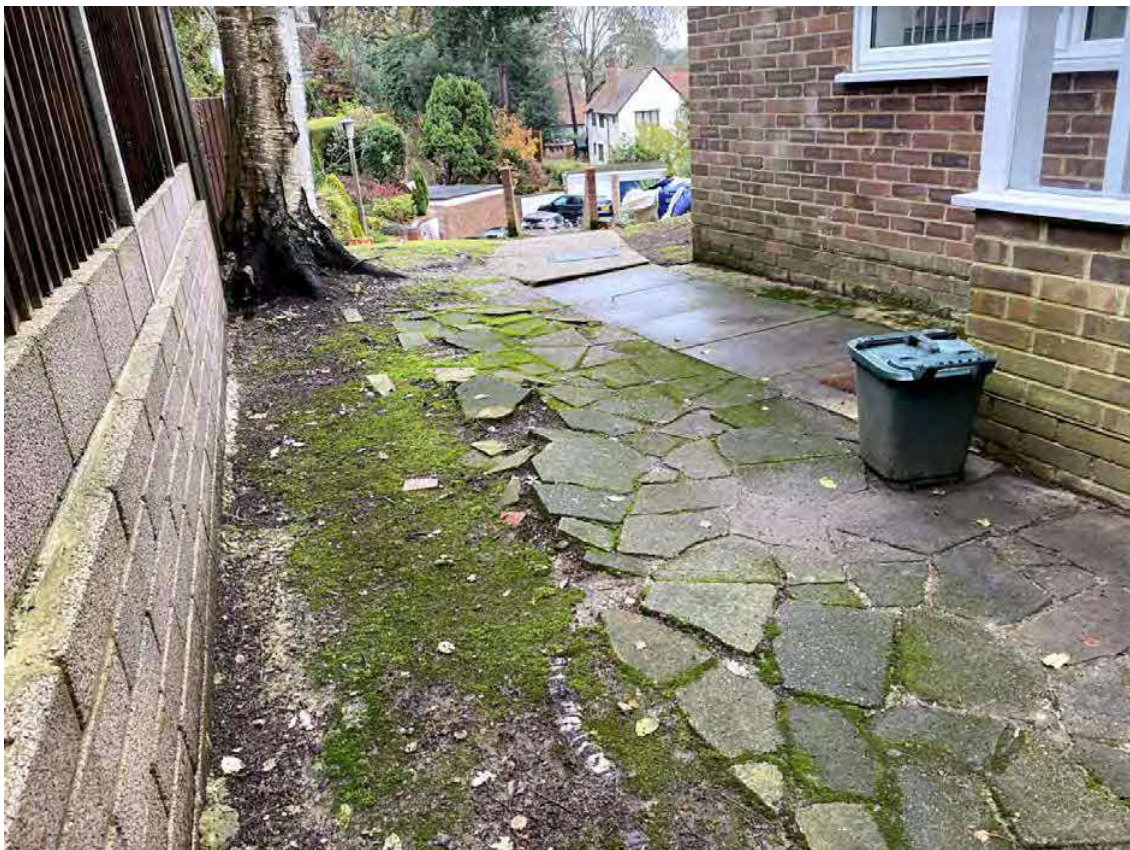
Photographic plate showing the roots of tree T1 damaging the footpath.

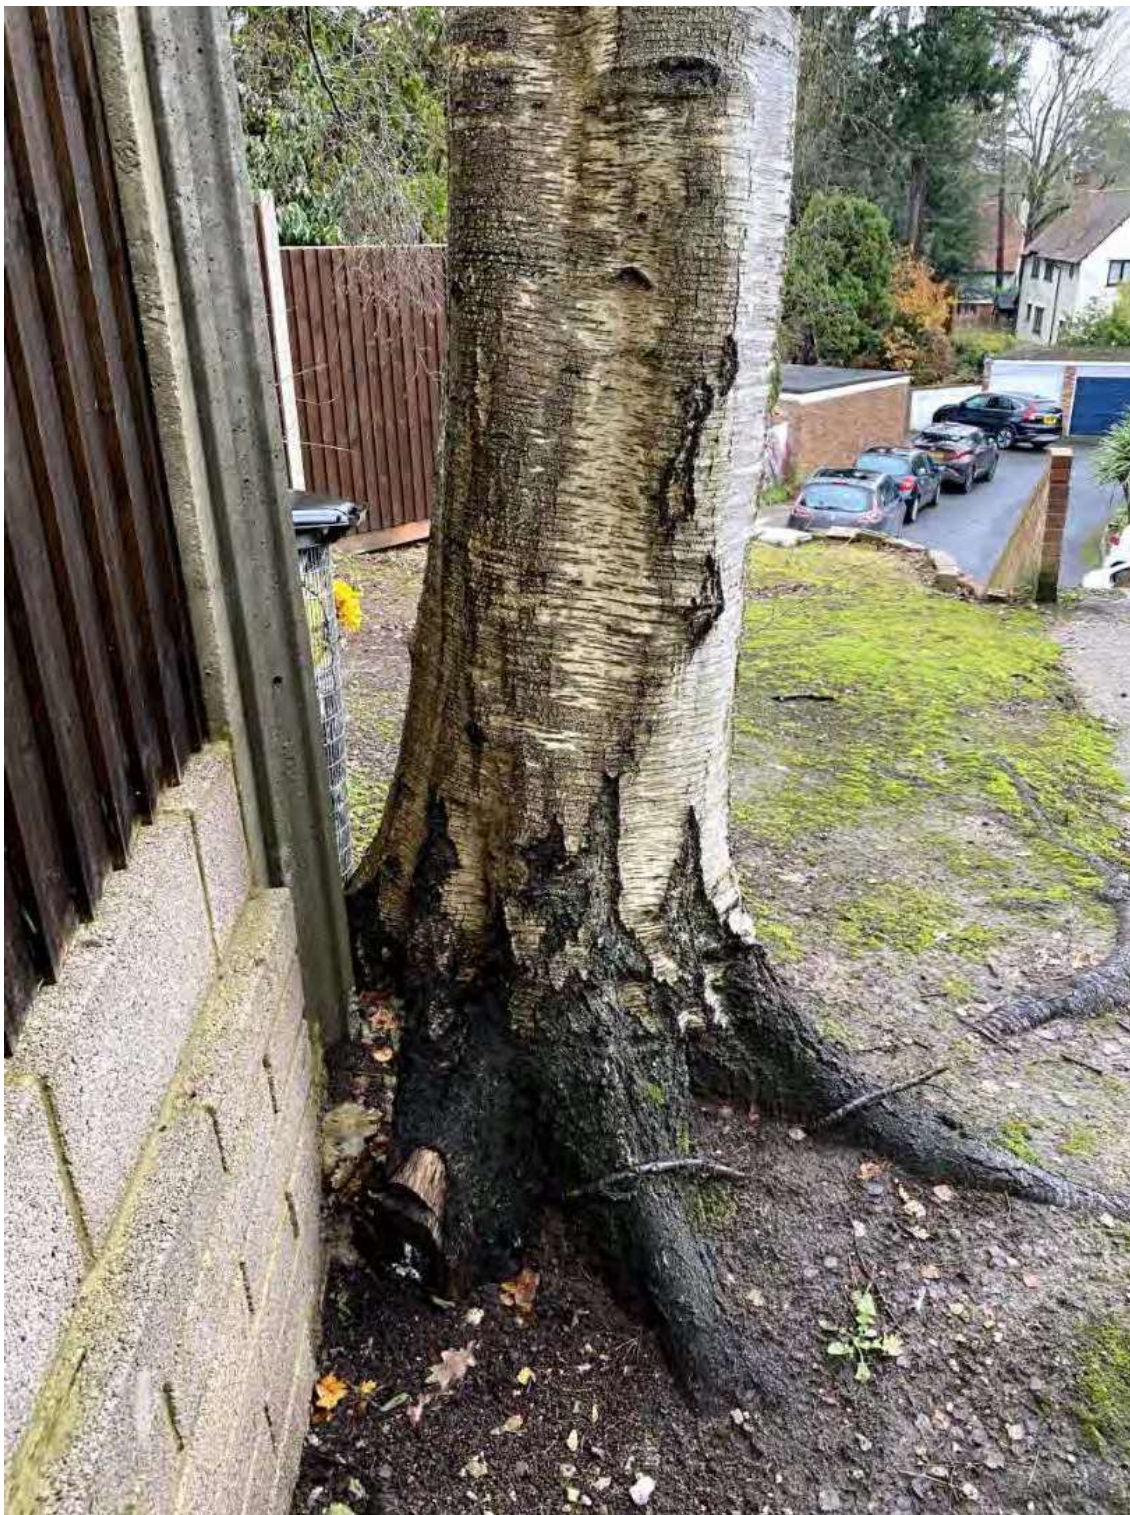
Photographic plate showing the base of tree T1.

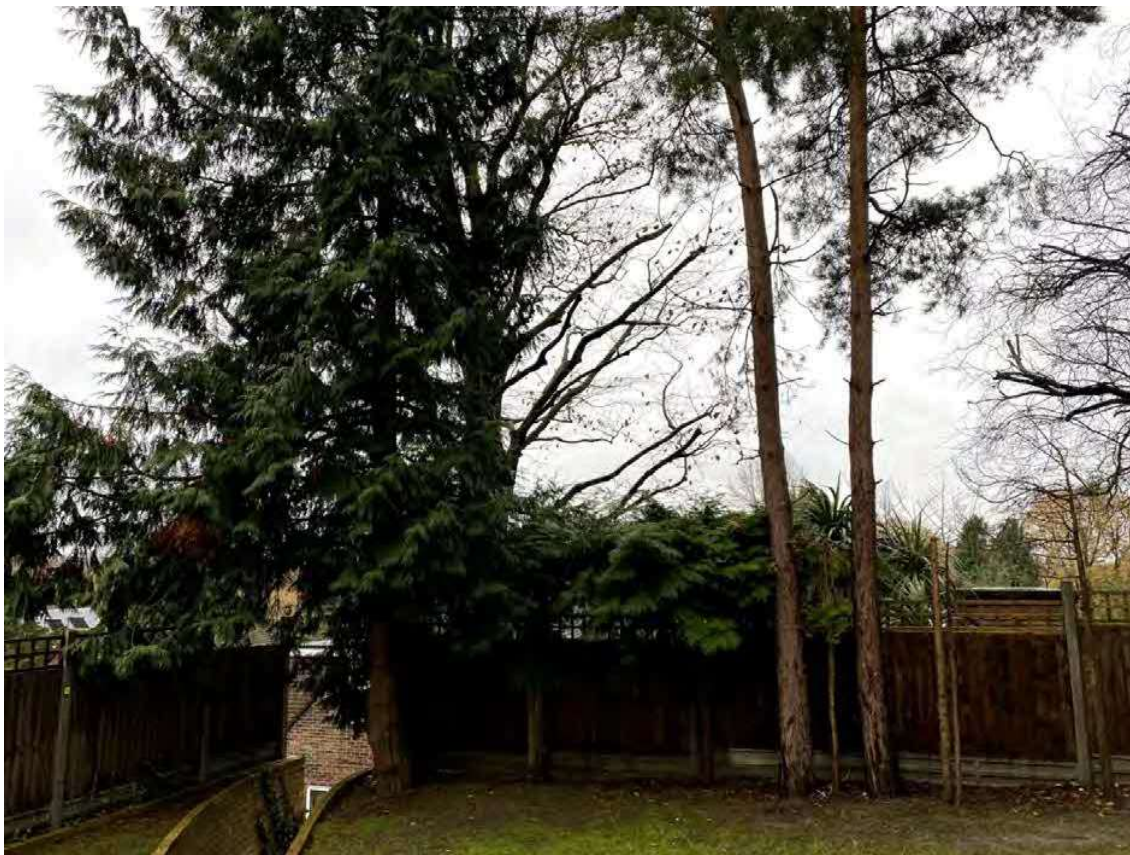
Photographic plate showing tree T3 and tree group G4, located on the site's boundary.

- 4.10 Tree T3 is a mature Leyland Cypress located on the site's southern boundary. The tree is part of a linear group. There have been ground level changes within the trees Root Protection Area and the tree is growing within a hard surface area of concrete. The branches hang low over the footpath and are encroaching upon the adjacent building.

- 4.11 Tree group G4 consists of two mature Scots Pine located on the site's southern boundary. The trees are part of a linear group. There have been ground level changes within the trees RPA and the trees are growing within a hard surface area of concrete. Mechanical damage was observed. The trees are of forest growth form. The branches hang low over the footpath.

- 4.12 Tree group G4 and trees T2 and T3 should be inspected annually.
- 4.13 The trees should be inspected sooner if there is a noticeable decline in condition, or following extreme weather events.
